Manhole Inspection Summary

Manhole # S35AA_030MH

Insp Date: **11/13/07 2:27 PM**

Location Address: **e.guilford**

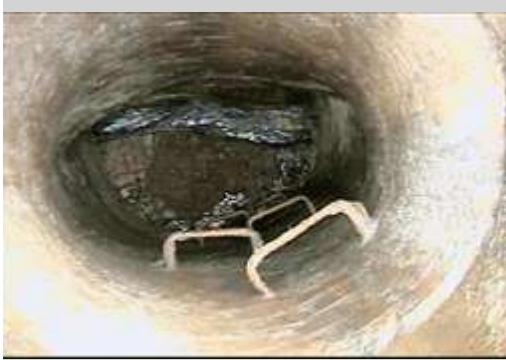
Defect 1

Steps Count: **5** Missing: **1** ☒ **Corroded**

corroded/missing steps

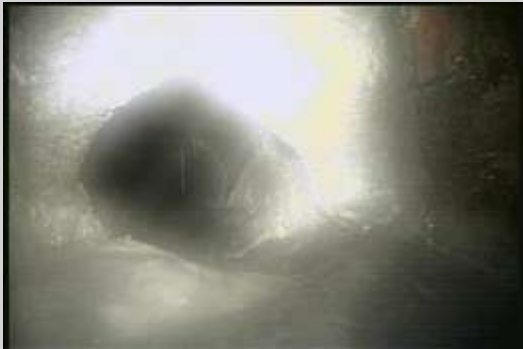
12 O'Clock Outflow

10 in. Circular Gravity Sewer
Pipe Out @ 12 O'Clock

Pipe Material: **Clay** ☐ Pipe Lined

Invert Depth: **9.65** (ft.) Flow Characteristics: **Slow**

Deposits: ☒ None ☐ Mud ☐ Sludge ☐ Debris ☐ Grease

Infiltration: **None** Pipe Seal Cond: **Unknown**
